TREE INVENTORY AND
PRESERVATION PLAN
Newmarket Toyota
Township of East Gwillimbury, York Region
October 2024

October 31, 2024
RS# 2024-227

***SUBJECT:* Tree Inventory and Preservation Plan, 1656 Green Lanes, Town of East Gwillimbury, York Region**

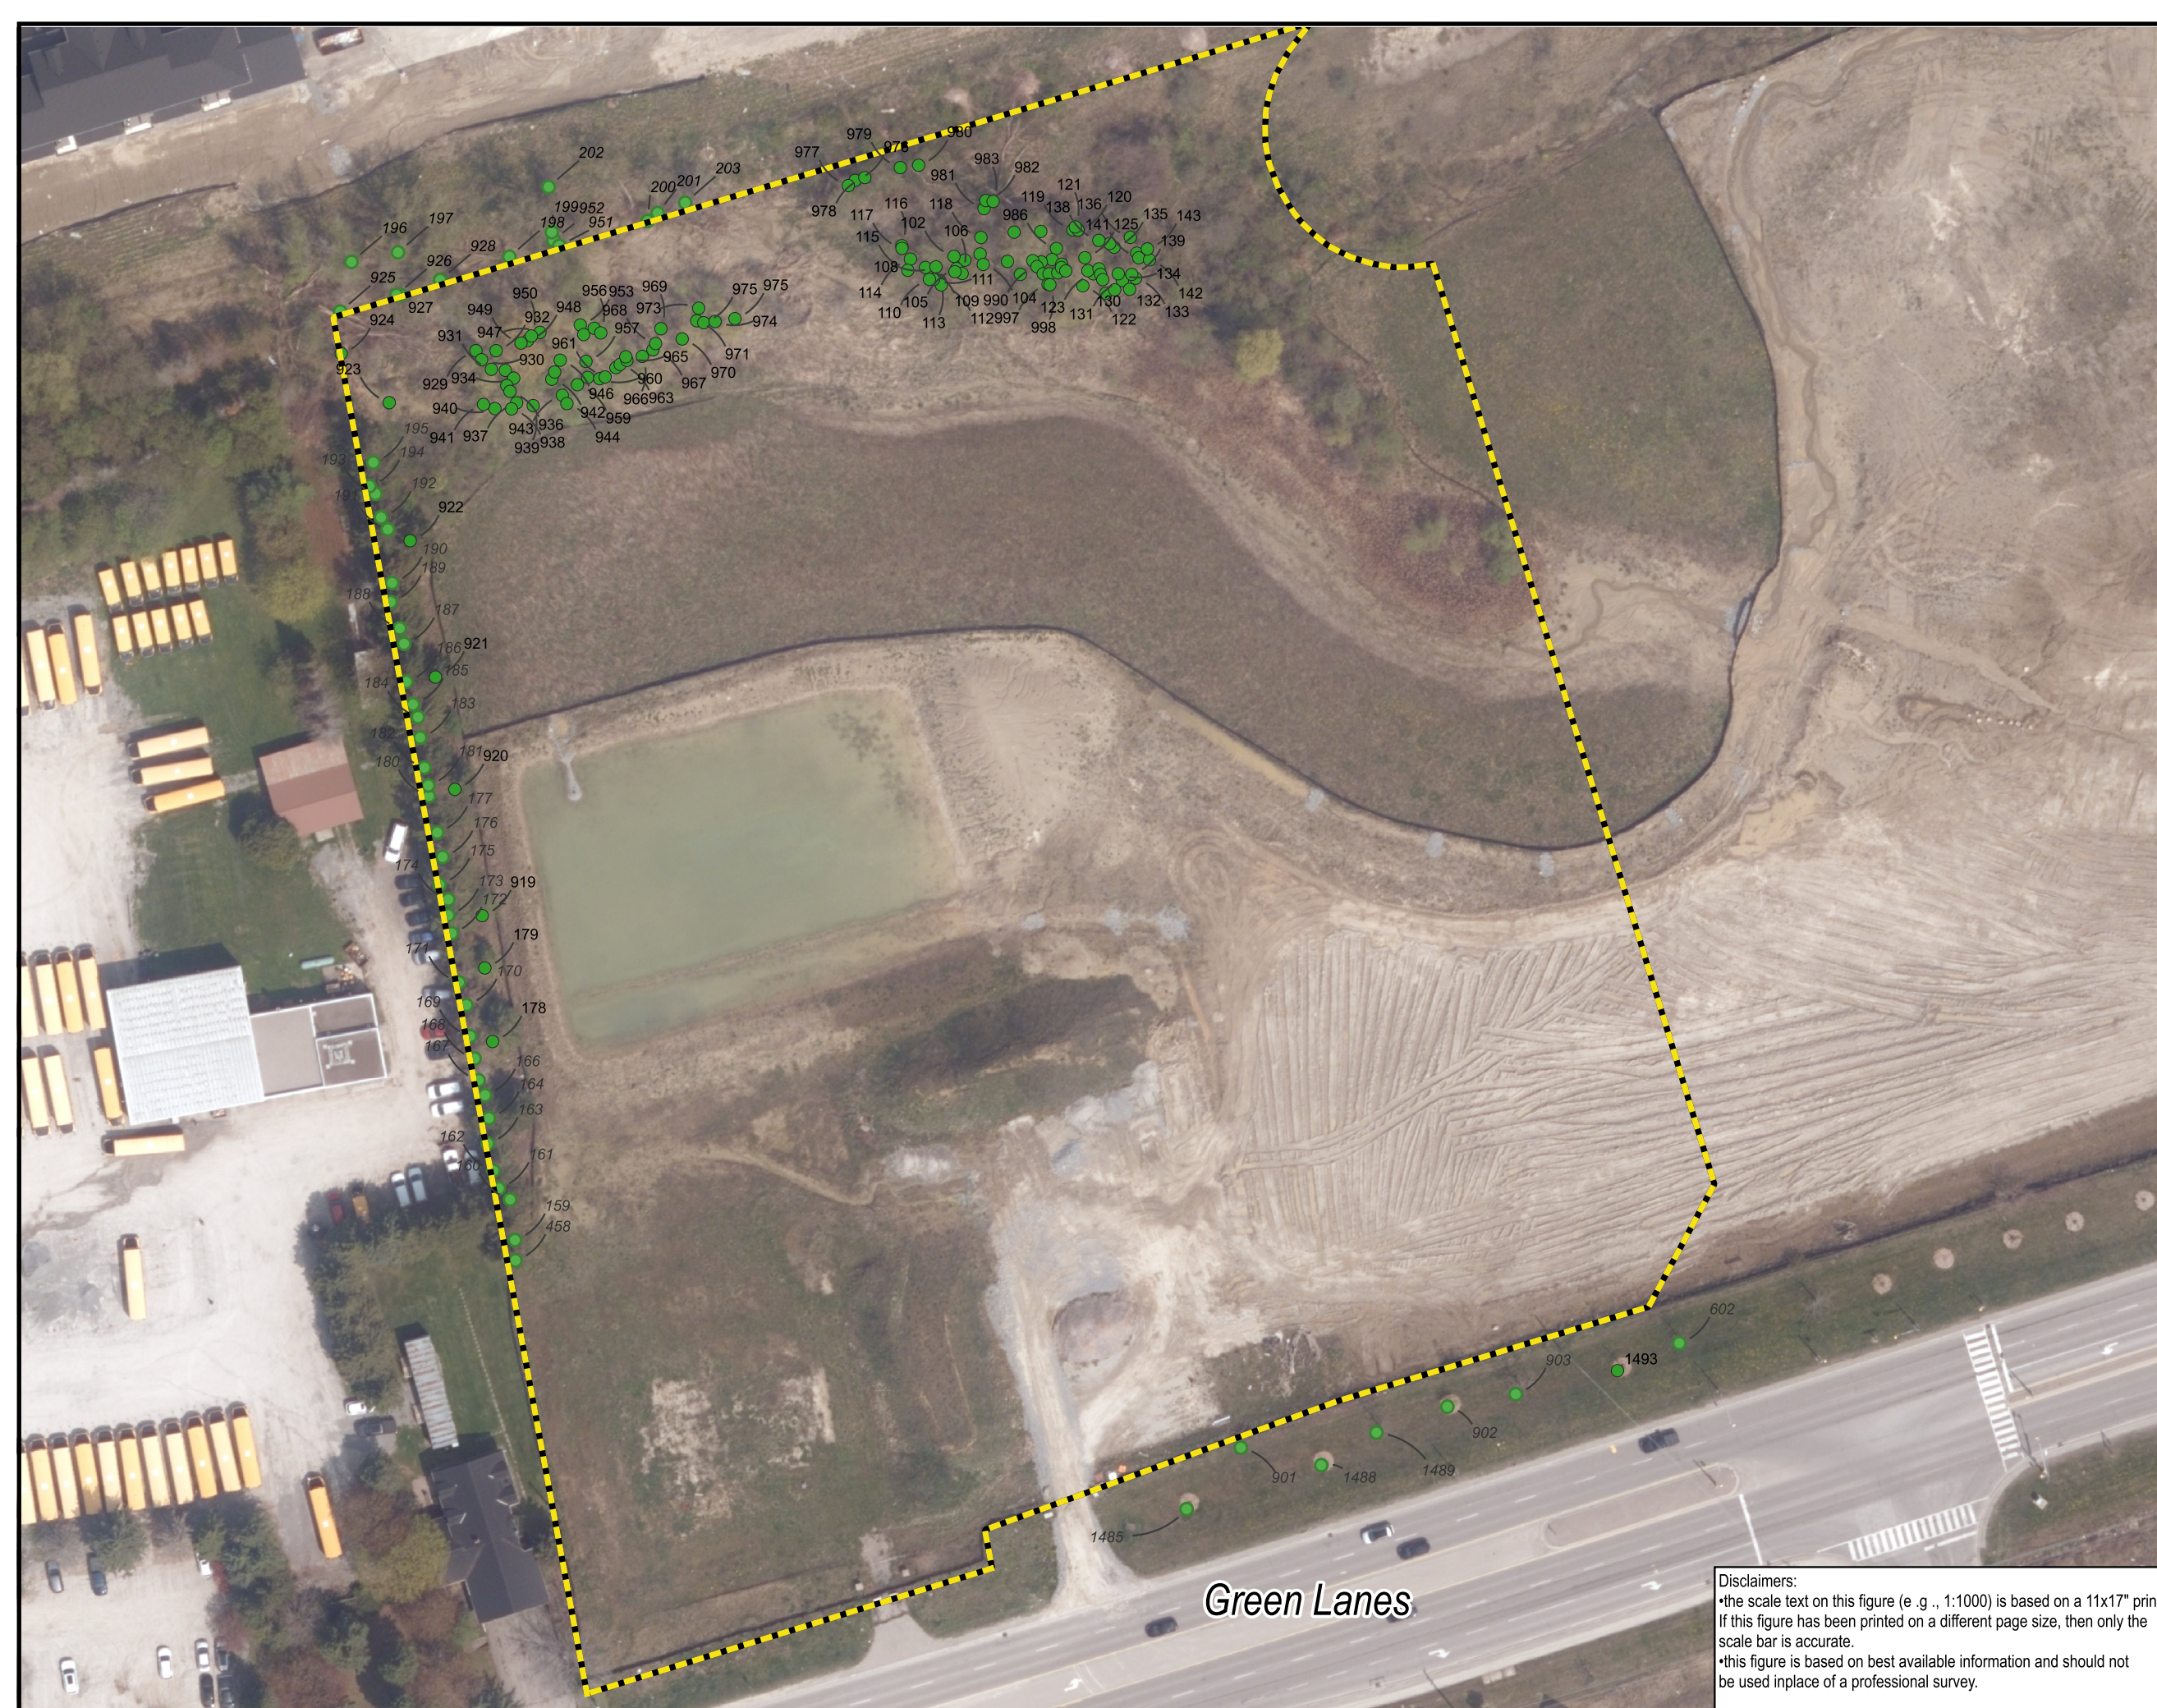
Figure 2. Tree Inventory and Protection Plan 1656 Green Lanes, Newmarket

The results of the tree inventory and health assessment area provide in **Appendix 1** and summarized below. The location of all trees assessed is provided in **Figure 2**.

A total of one hundred and eighty (180) trees were assessed in this study with tree tags 101-143, 147, 148, 158-203, 602, 901-903, 919-1000, 1485, 1488, 1489, and 1493. Trees located on adjacent lands where permission was not granted were assessed through estimation and given tag numbers but not physically tagged. Trees inventoried consisted primarily of deciduous species with conifer species confined to a hedgerow along the east property boundary. Trees ranged from young to over-mature, with sizes that ranged from less than 10 cm DBH to 54 cm DBH. Tree composition and abundance is summarized below in **Table 1**. Nine (9) different species were documented within the subject property and/or directly adjacent to the development boundary with the following species being present, American Elm (*Ulmus americana*), Balsam Poplar (*Populus balsamifera*), Black Walnut (*Juglans nigra*), Horse Chestnut (*Aesculus hippocastanum*), Kentucky Coffee Tree (*Gymnocladus dioica*), Manitoba Maple (*Acer negundo*), Northern Red Oak (*Quercus rubra*), White Spruce (*Picea glauca*) and Willow Species (*Salix sp.*). A number of trees were noted as unknown due to level of decline. The complete inventory and health assessment of trees can be found in **Appendix 1**.

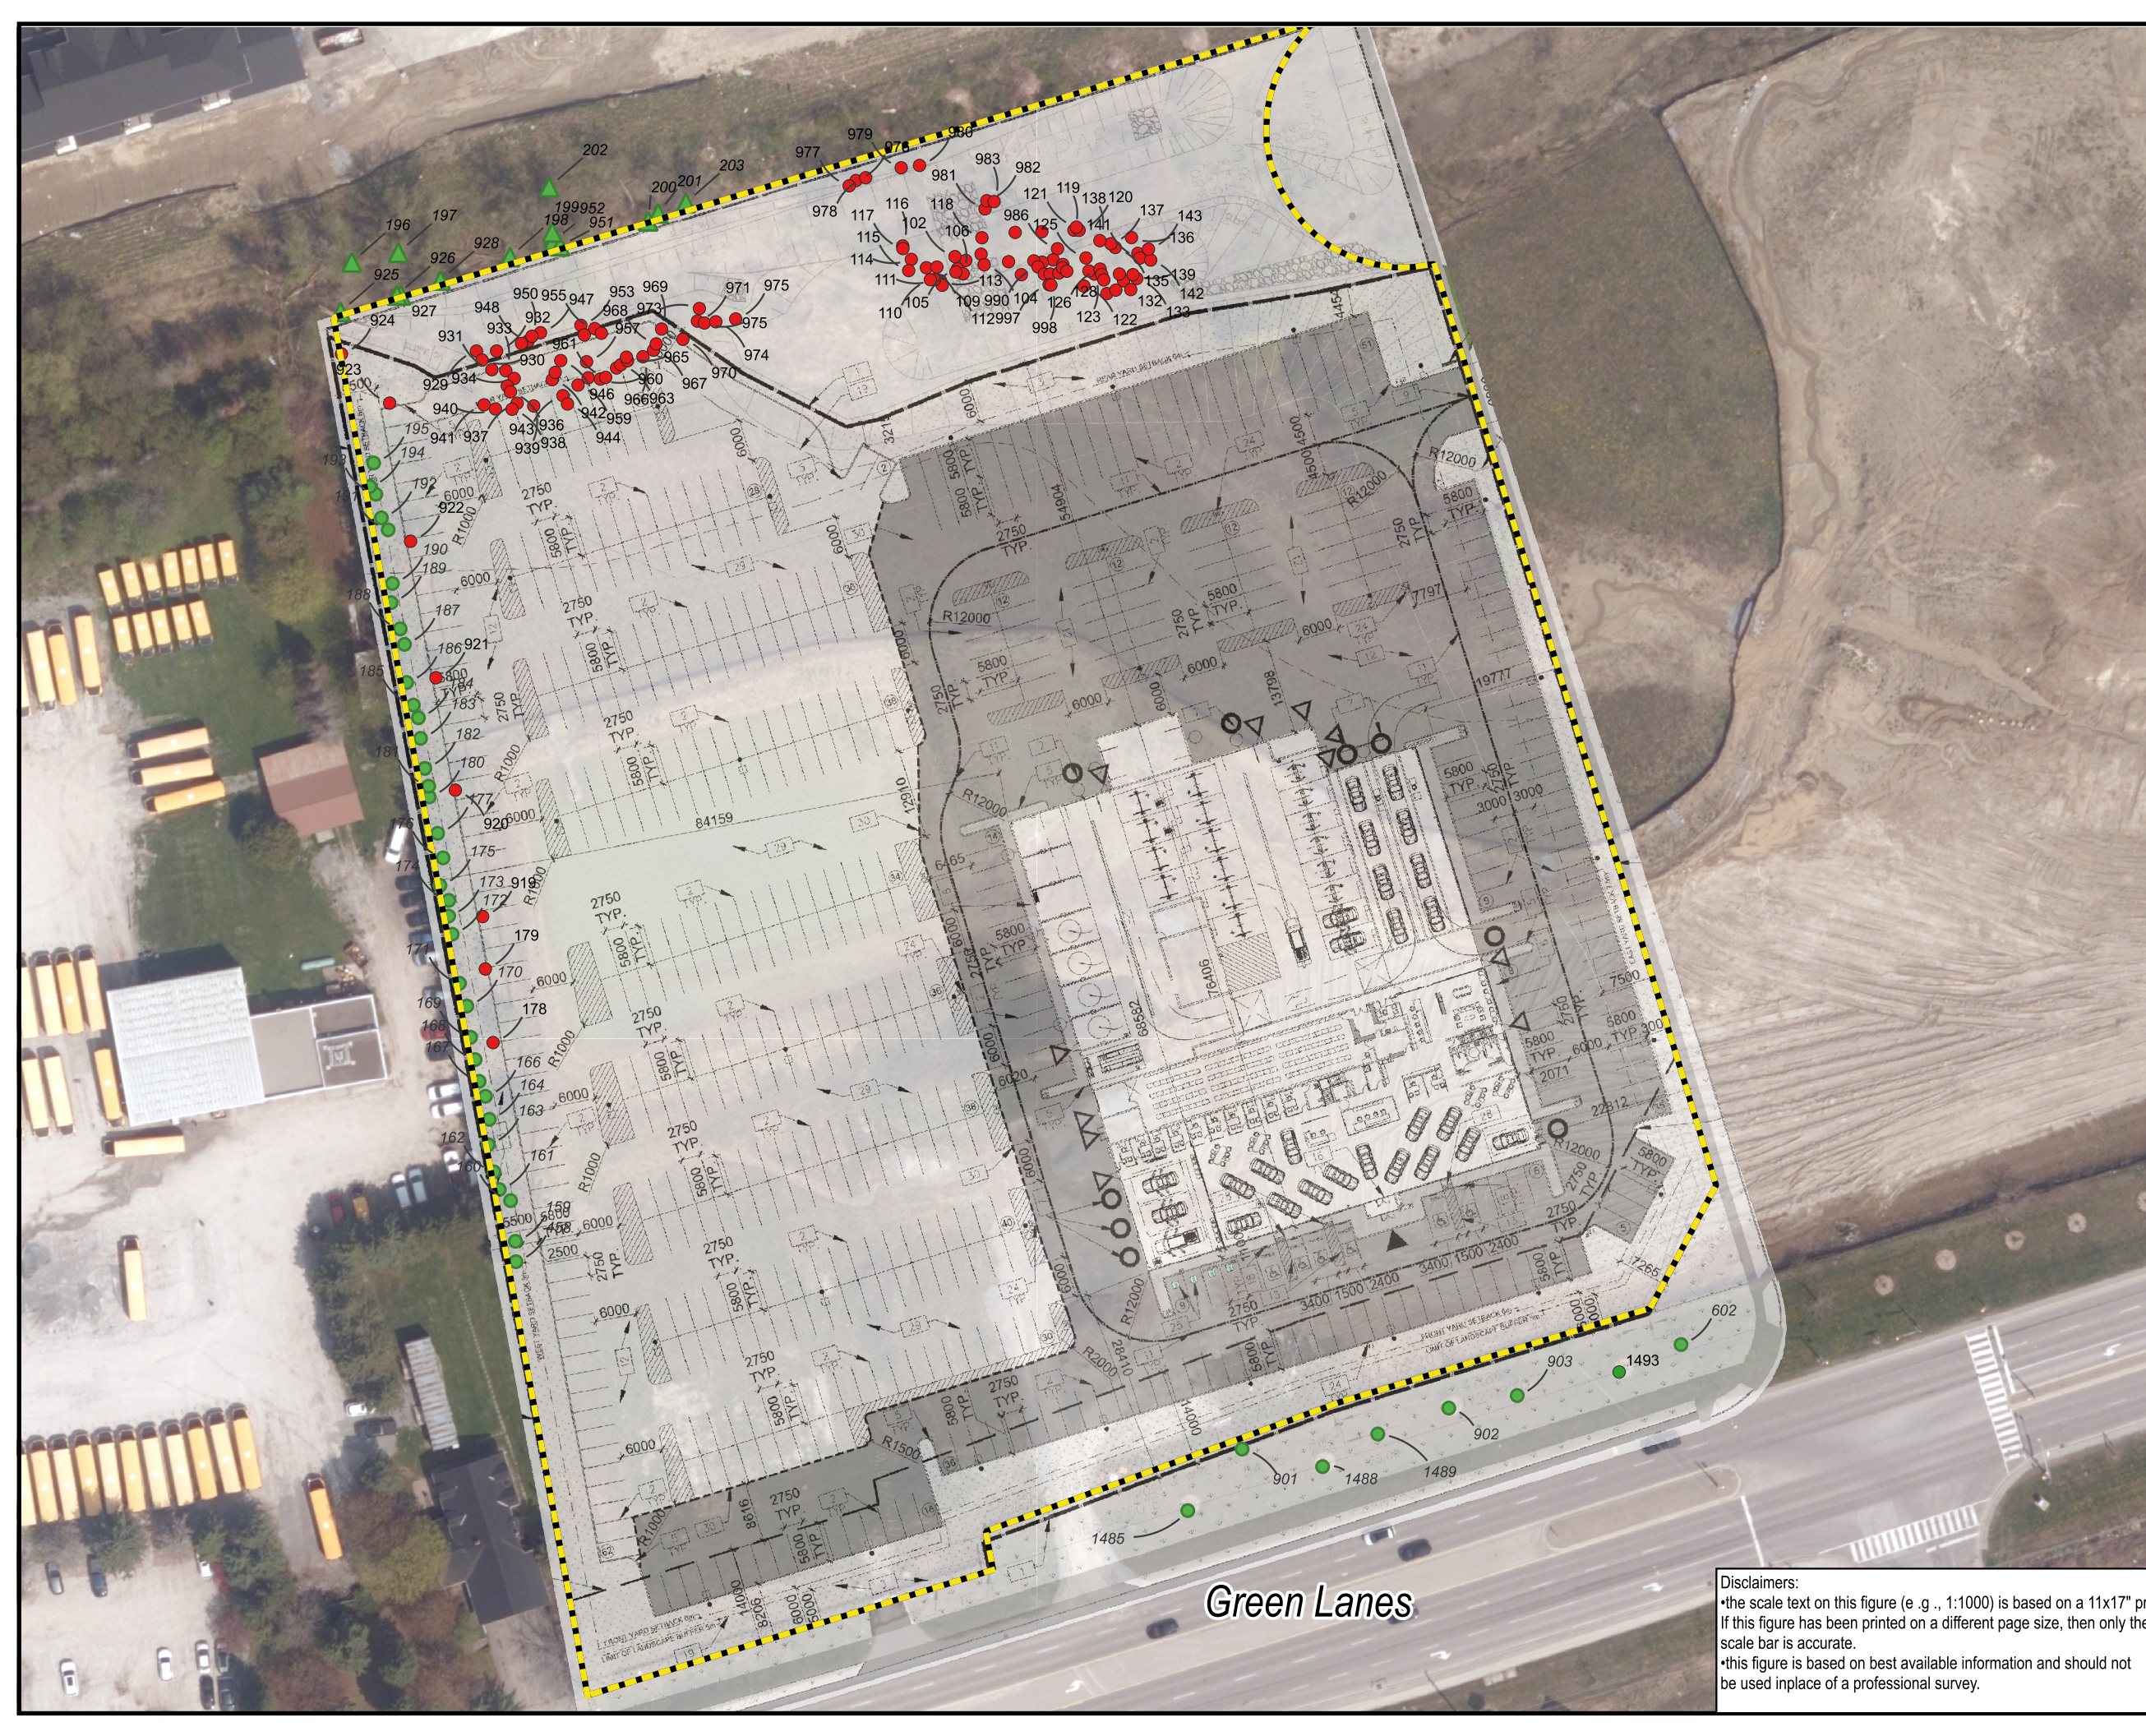
**Figure 3. Tree Inventory and Protection Plan
1656 Green Lanes, Newmarket**

As shown on **Figure 3**, a total of one hundred and eighty (180) inventoried trees require removal to implement the proposed development, of these trees all are located on private land with no trees located in York Region owned lands. This assessment includes all trees including those that were found to be dead. All trees within the main portion of the subject property are proposed to be removed with trees to remain along the west property boundary and on adjacent lands to the south and north. Given the proximity of the trees recommended for retention, the position of required tree protection fencing will be along the edge of the east and north development boundary where adjacent trees are present and around individual trees within York Region owned lands along Green Lanes. It is expected that the construction activities will result in disturbance to the root system of proximate trees. Recommendation for protection of these trees fall under the Region's Tree Preservation and Planting Design Guidelines and are outlined below.

Figure 3 show trees to be protected. All trees have been documented using a high accuracy GPS, however this is not a substitute for a formal OLS survey of trees and property boundaries. To protect trees that will be retained along the west, north and south property boundaries and to verify ownership of trees, RiverStone recommends the following measures:

- **Prior to removal of any trees adjacent to lands not owned by the client, adjacent owners should be notified and**
- **All trees that are not to be removed are to be preserved, tree preservation fencing is outlined on Figure 3 .**

- **Root-sensitive excavation shall be undertaken along the development where tree barrier fencing is located adjacent to retained trees, this included areas indicated on Figure 3 with barrier fencing.**
