COSTCO WHOLESALE

TOWN OF NEWMARKET

COSTCO BUSINESS CENTRE

TREE PRESERVATION PLAN

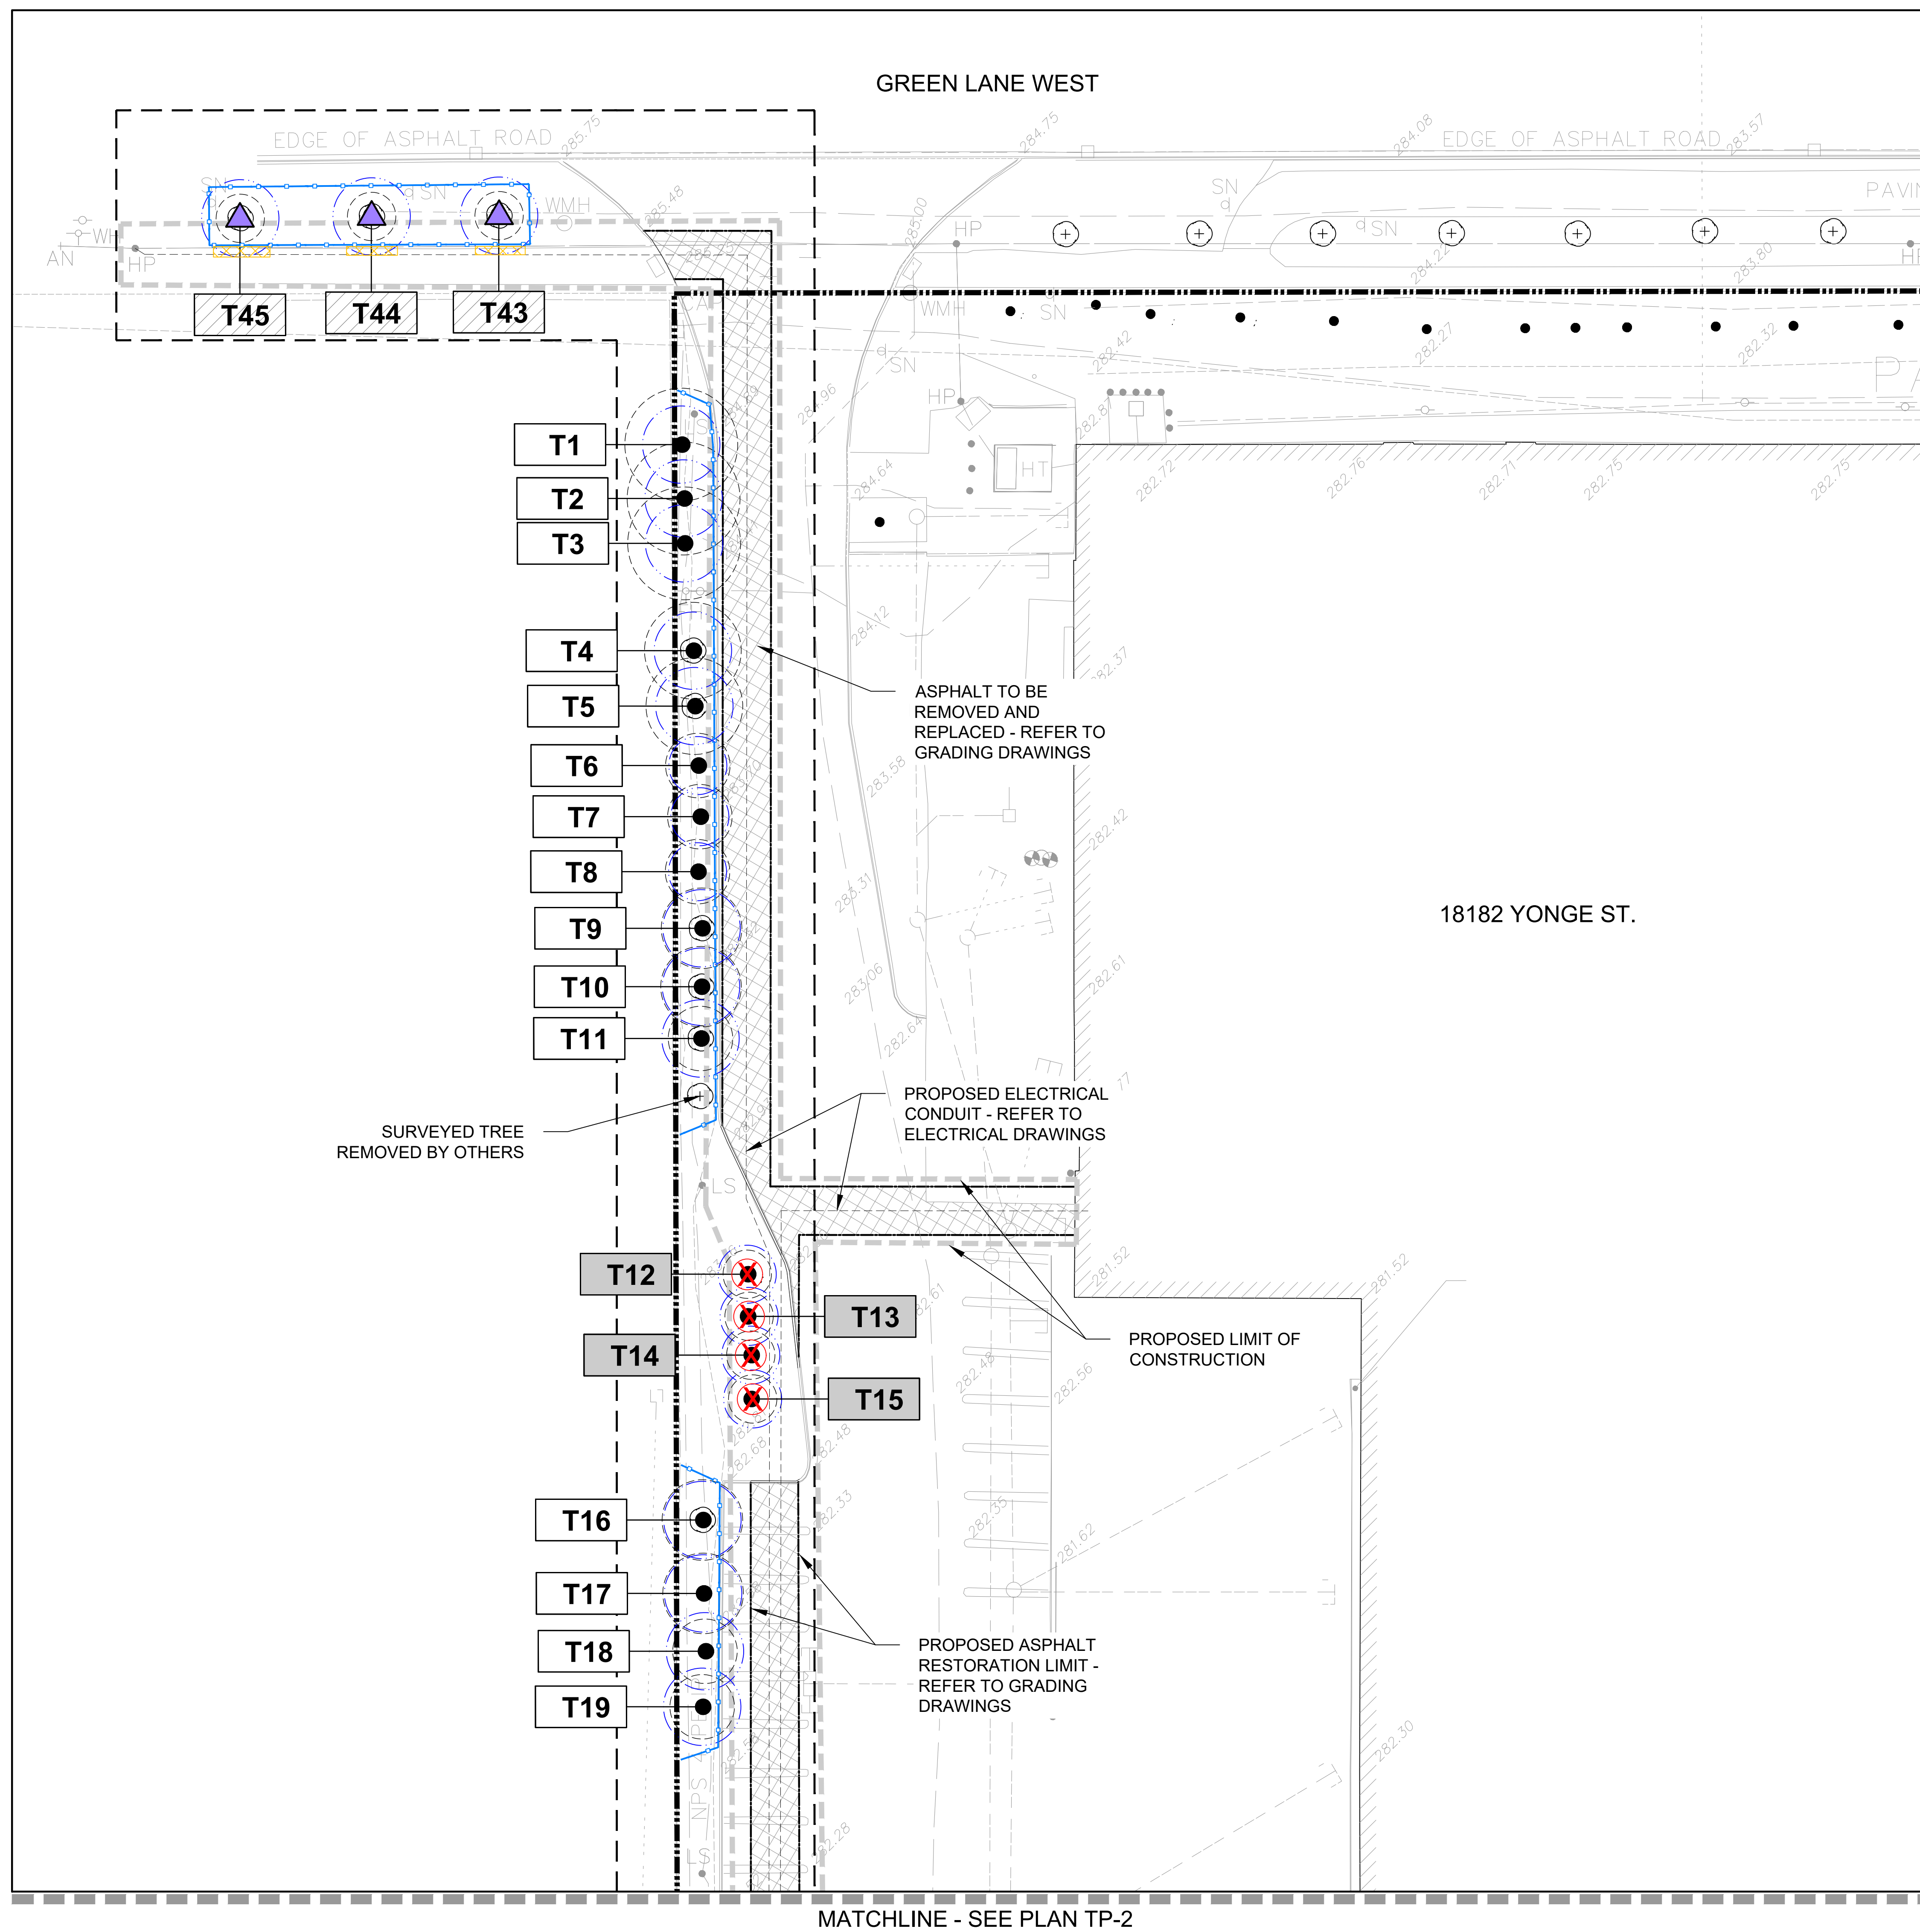
1 TREE PRESERVATION PLAN
1:200

- LEGEND:
- T000** TREE INVENTORY NUMBER - TREE TO BE PRESERVED/RETAINED
 - T000** TREE INVENTORY NUMBER - TREE TO BE PRESERVED WITH INJURY
 - T000** TREE INVENTORY NUMBER - TREE TO BE REMOVED
 - SURVEYED TREE LOCATION
 - ▲ INDIVIDUAL TREE TO BE PRESERVED WITH INJURY
 - ⊗ INDIVIDUAL TREE TO BE REMOVED DUE TO PROPOSED CONSTRUCTION
 - TREE PROTECTION ZONE (TPZ) FOR TREE LOCATED WITHIN YORK REGIONAL ROAD ALLOWANCE
 - APPROXIMATE DRIPLINE OF TREE CANOPY
 - ▨ ENCROACHMENT WITHIN THE TPZ
 - TREE PRESERVATION FENCE
 - - - PROPERTY BOUNDARY
 - - - TREE INVENTORY BOUNDARY
